3D PROPERTY INSPECTIONS LLC

SAMPLE INSPECTION REPORT

1234 Main Street
Yakima, WA 98903

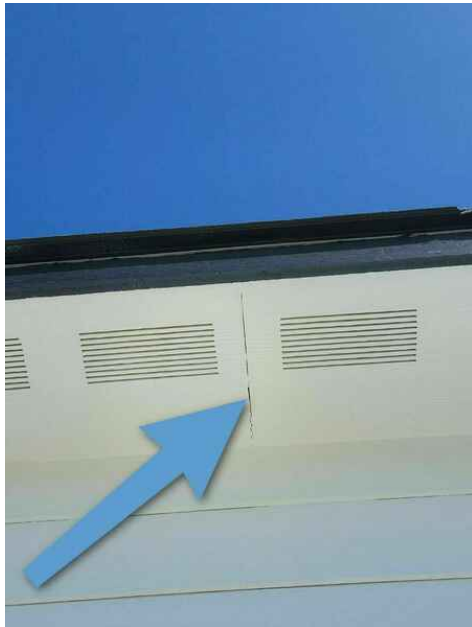
The sealant at siding penetrations (e.g., piping, water faucets, etc.) and siding transitions (e.g., siding to trim, trim to windows, etc.) was deteriorated, missing, and/or weathered. This condition can potentially lead to moisture into the wall cavity. Recommend applying sealant as needed.

South side eaves.

Contact a handyman or DIY project

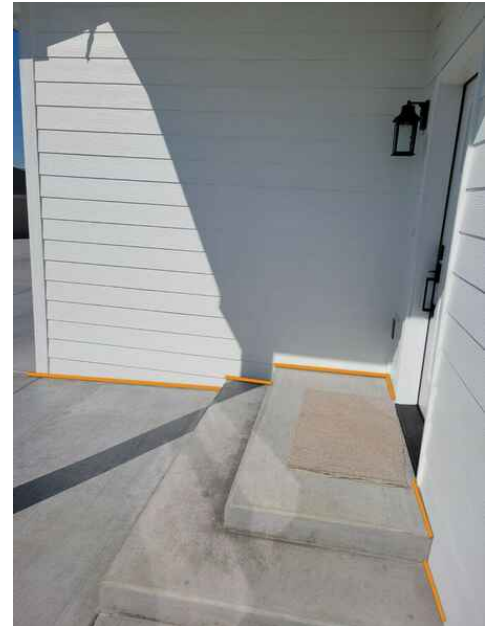
Inadequate clearance between siding and ground was observed. Siding in contact with hard surfaces can lead to moisture damage to the siding material. A 2-inch clearance between the bottom of the siding and any hard surfaces such as a concrete walkway is typically recommended. Recommend a qualified contractor to make repairs. Recommend monitoring these areas of siding for moisture damage.

Contact a qualified siding specialist.

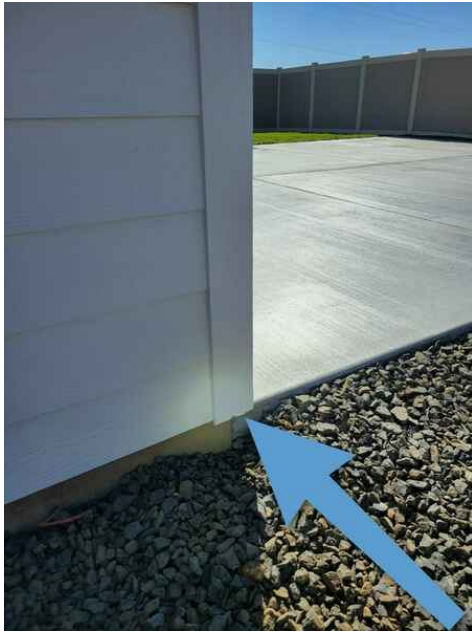
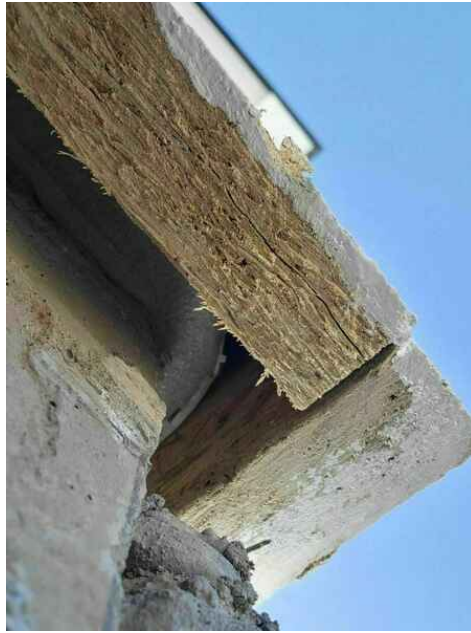
3.2.1 Exterior Trim

MISSING PAINT

One or more area(s) of the trim was missing exterior paint. To avoid moisture damage, recommend painting the area(s).

Exposed/unpainted wood.

Contact a handyman or DIY project

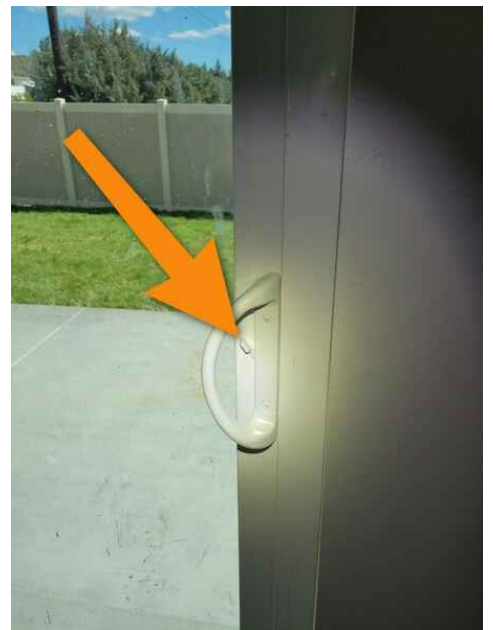
3.4.1 Exterior Doors

The locks on one or more doors were difficult to operate. Recommend a qualified contractor to make adjustments.

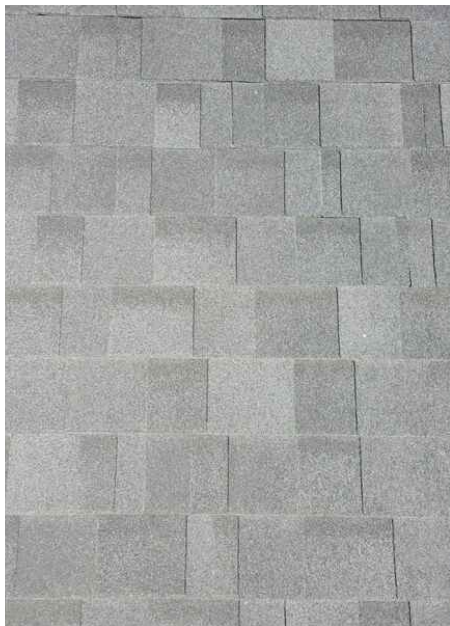
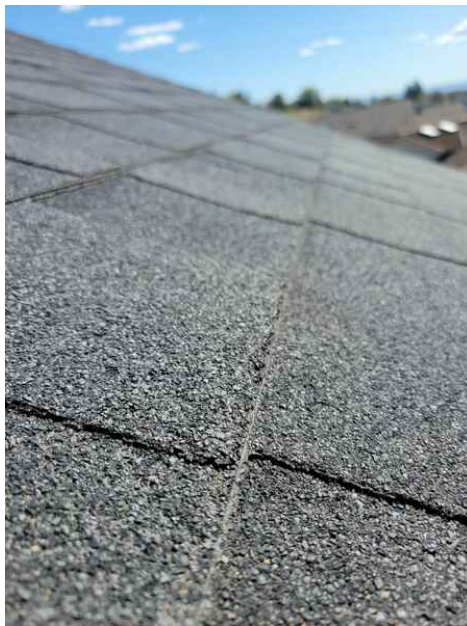
Asphalt Composition System: Serviceable

The visible components of the roof covering materials appeared in acceptable condition and appeared to function as intended, unless otherwise specified in this report.

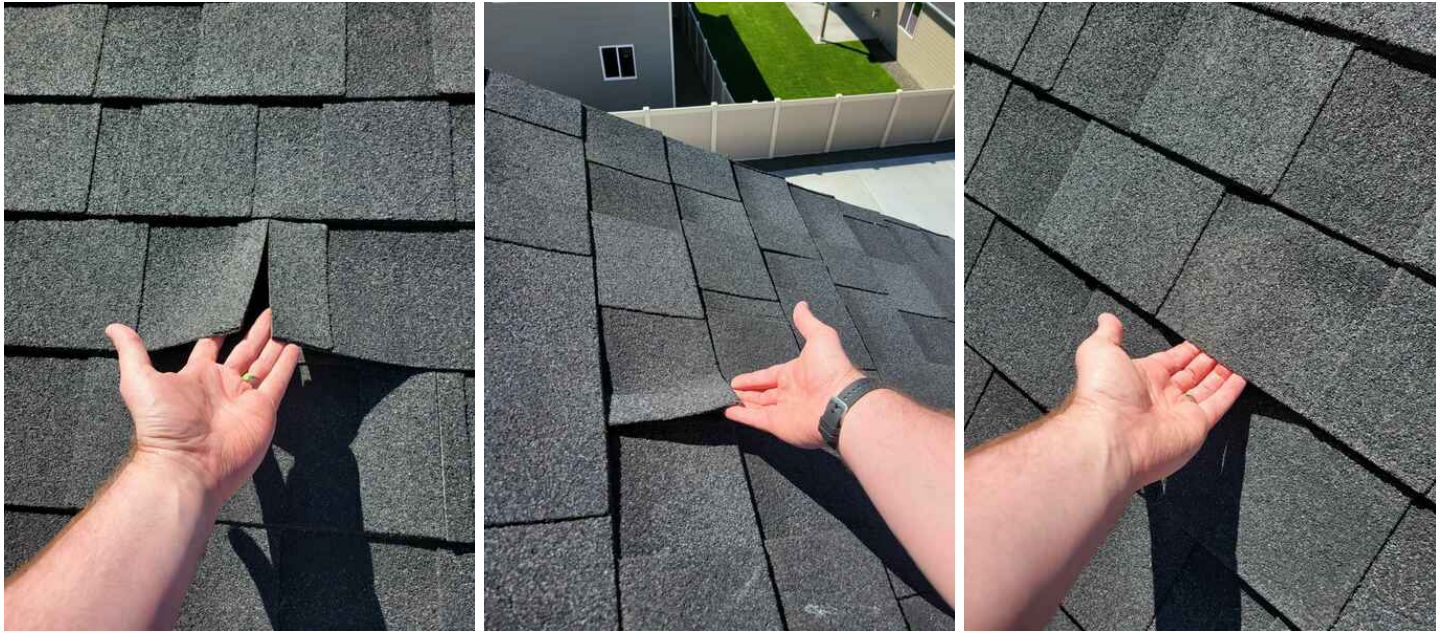
LOOSE MATERIAL

The inspector observed areas of loose and/or unsecured shingles. This condition can lead to wind/weather damage and potential roof leaks if not repaired. Recommend qualified contractor to make repairs.

Contact a qualified roofing professional.

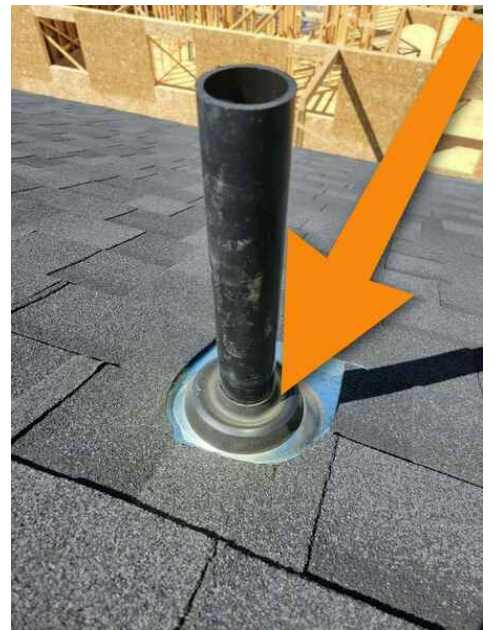
4.2.1 Roof Flashings

INVERTED VENT PIPE FLASHING

One or more rubber vent flashings were inverted. This can lead to deterioration and moisture intrusion as water can not run off the flashing as intended. Recommend a qualified contractor to make repairs.

Contact a qualified roofing professional.

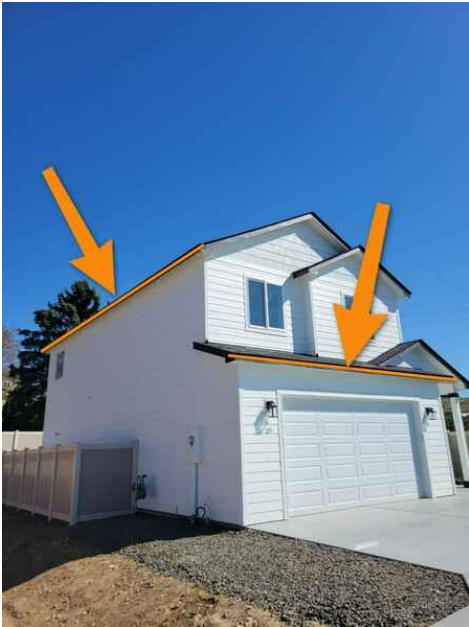
GUTTER SYSTEM MISSING

The roof was missing gutters in one or more locations. The purpose of gutters is to protect the house from water runoff by diverting it away from your home and its foundation. Recommend a qualified contractor to install a gutter system as needed.

Contact a qualified gutter contractor

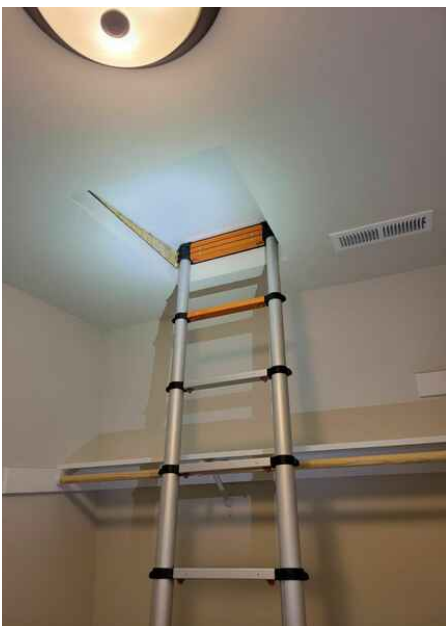
Access Condition: Serviceable

The attic access appeared in acceptable condition and appeared to function as intended, unless otherwise specified in this report.

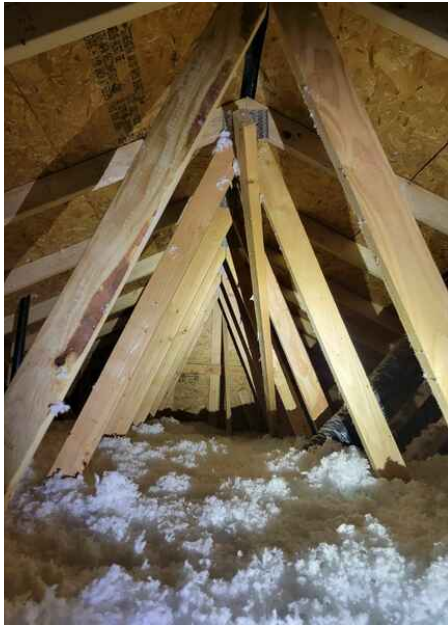
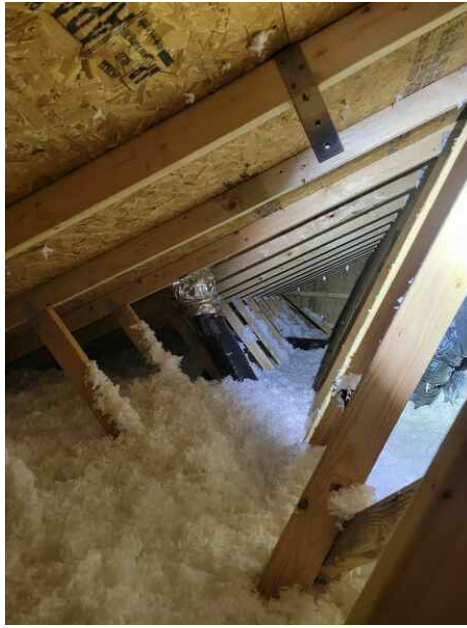
Attic Space Condition: Serviceable

The attic space appeared in acceptable condition and appeared to function as intended, unless otherwise specified in this report.

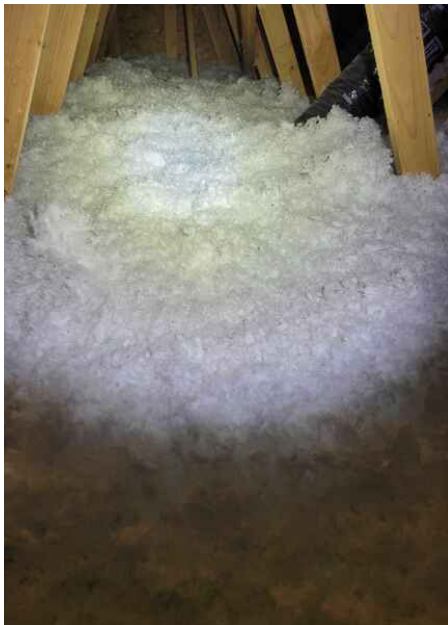
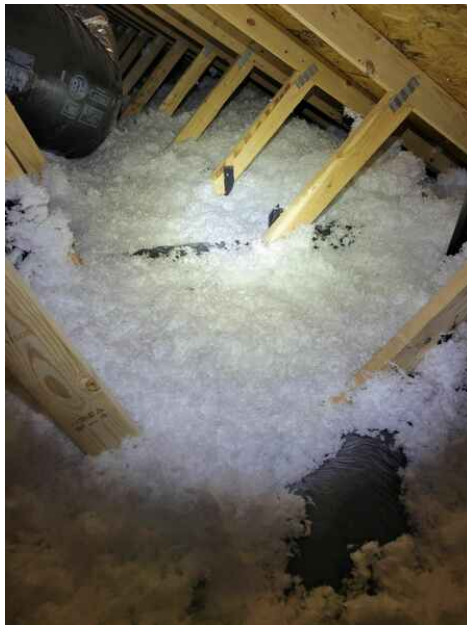
Insulation Condition: Serviceable

The attic insulation appeared in acceptable condition and appeared to function as intended, unless otherwise specified in this report.

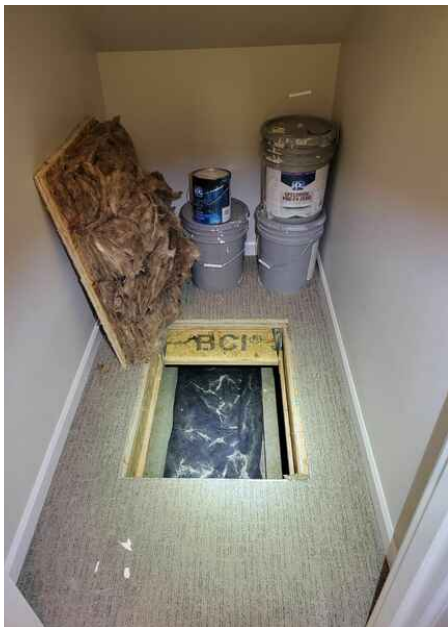
Access Condition: Serviceable

The crawlspace access appeared in acceptable condition and appeared to function as intended, unless otherwise specified in this report.

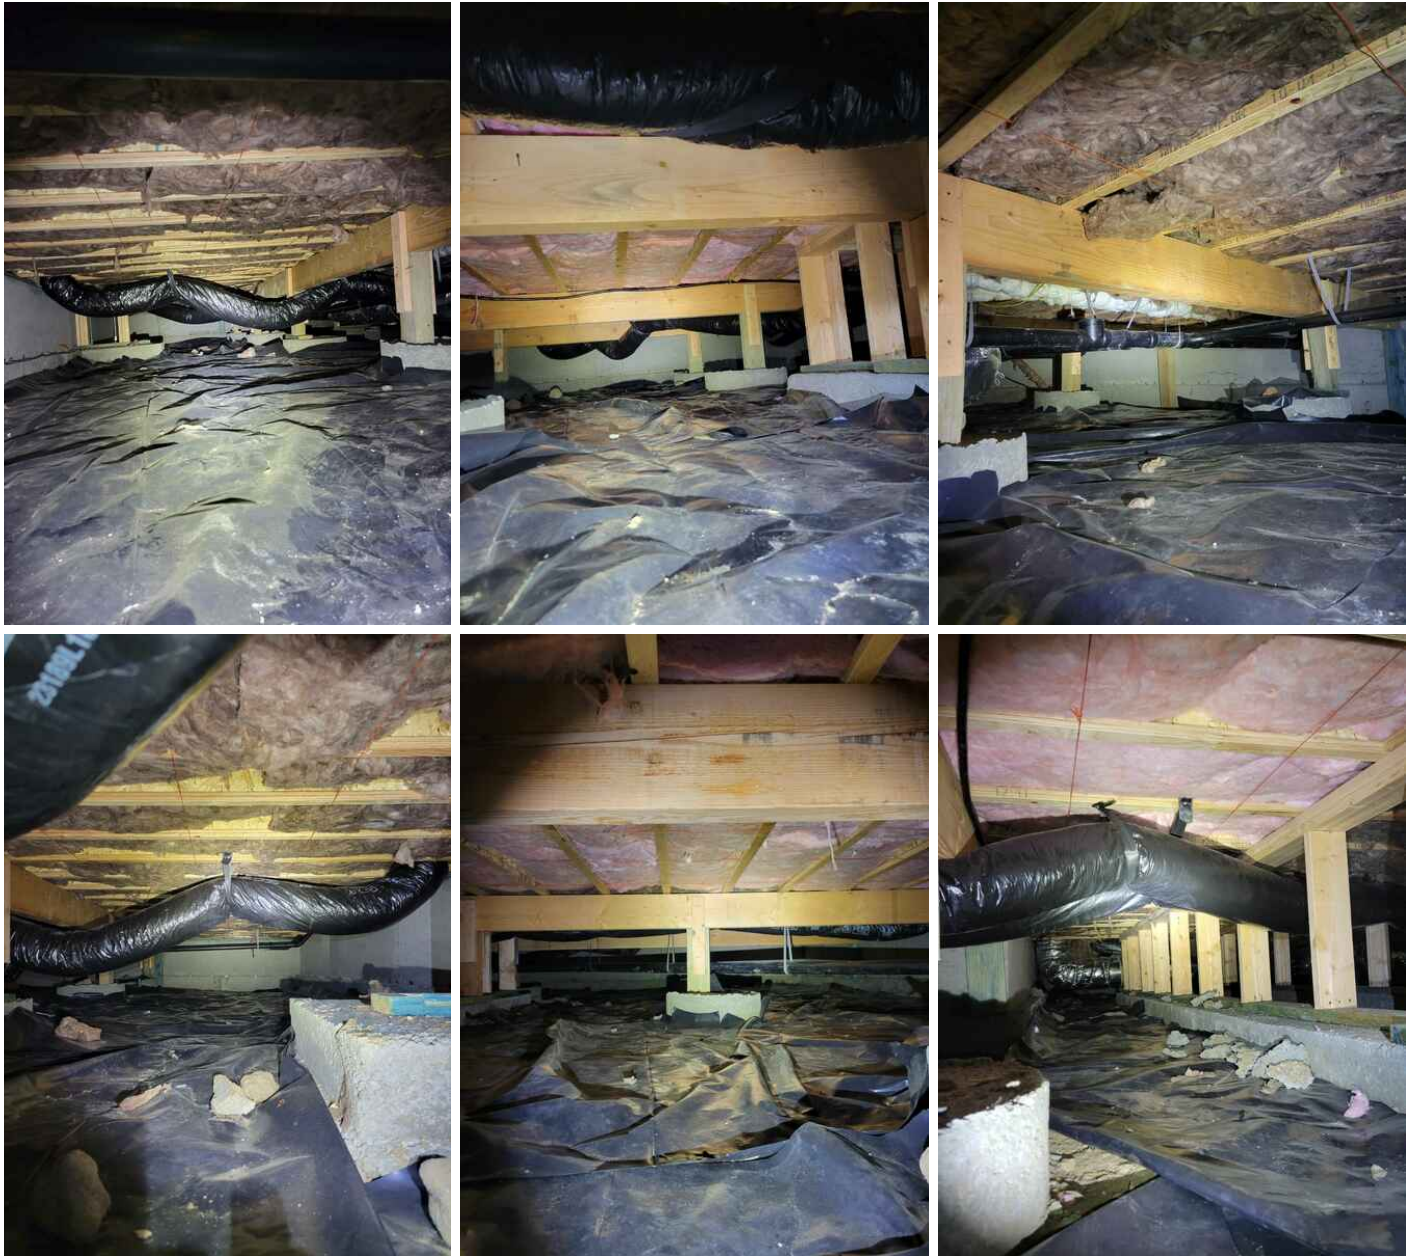
Crawlspace Condition: Serviceable

The visible and readily accessible areas of the crawlspace appeared in acceptable condition and appeared to function as intended, unless otherwise specified in this report.

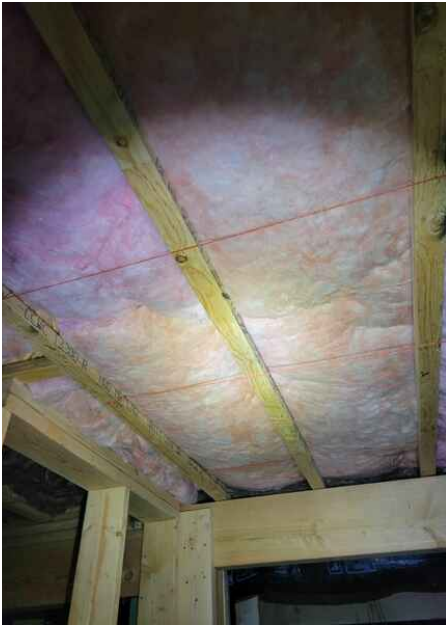
Insulation Condition: Serviceable

The floor insulation in the crawlspace appeared in acceptable condition and appeared to function as intended, unless otherwise specified in this report.

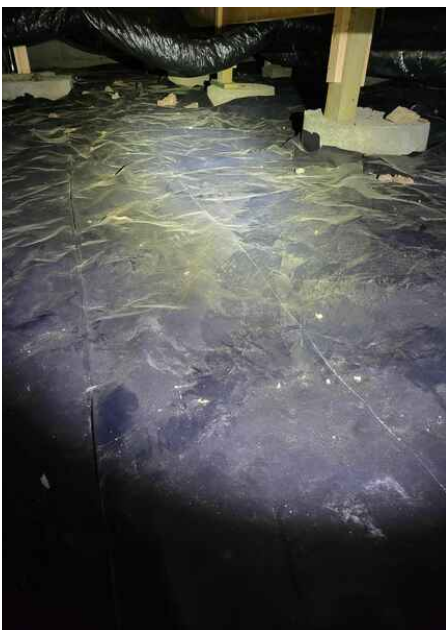
Vapor Barrier: Serviceable

The vapor barrier in the crawlspace appeared in acceptable condition and appeared to function as intended, unless otherwise specified in this report.

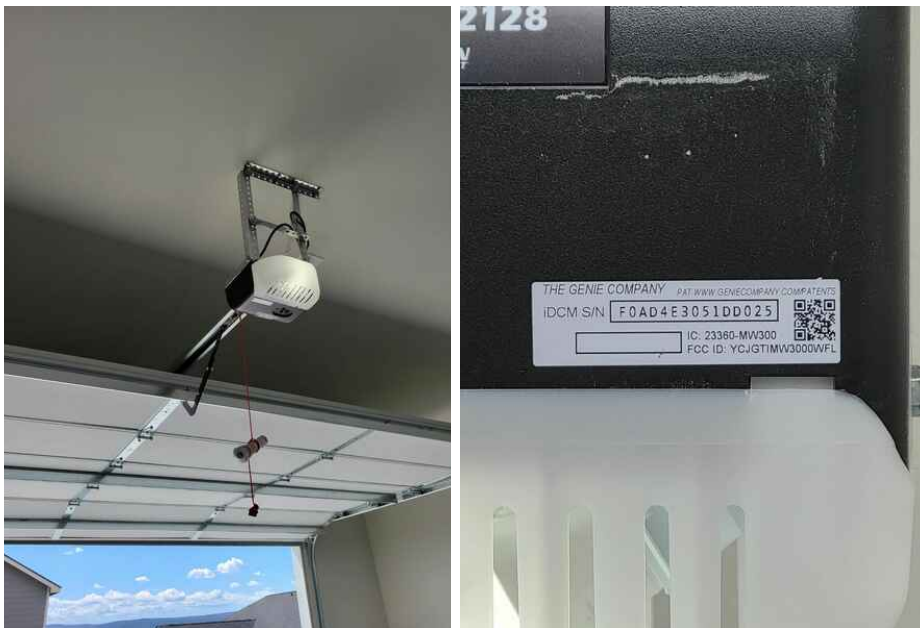
Vehicle Door Opener(s): Serviceable

The automated garage vehicle door opener(s) appeared in acceptable condition and appeared to function as intended, unless otherwise specified in this report.

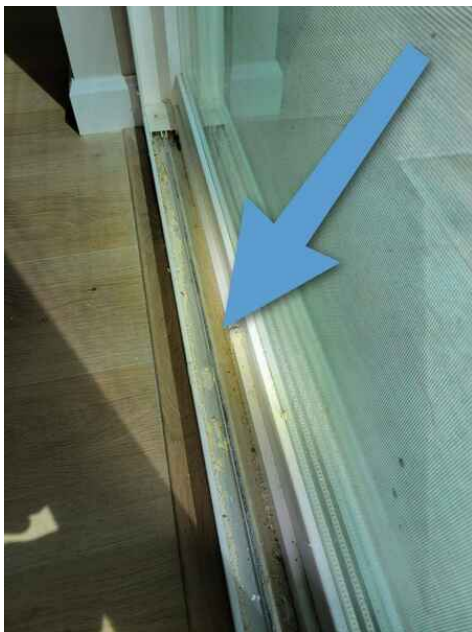
Debris was observed in one or more window and door rails at the time of inspection. This condition can cause the window/door to not operate properly. Recommend a qualified contractor to clean the rails.

Glass sliding door rail.

Contact a handyman or DIY project

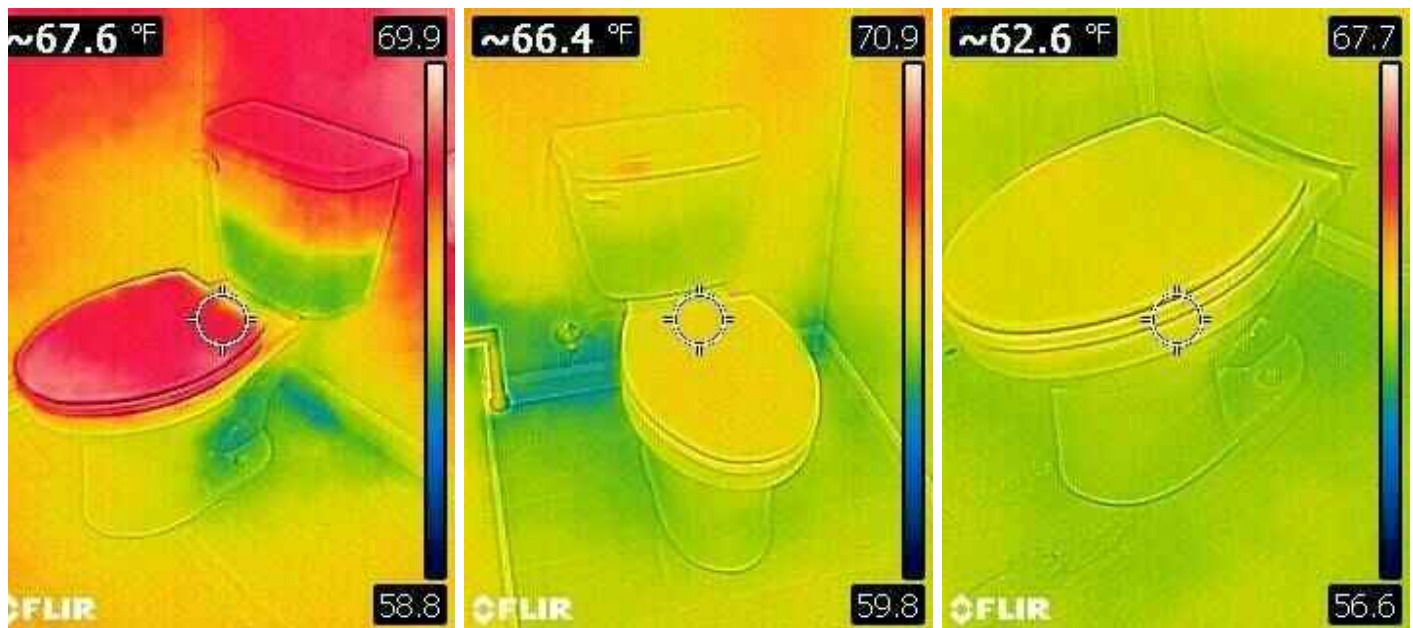
Bathroom Toilet(s): Serviceable

The toilet(s) appeared in acceptable condition and appeared to function as intended, unless otherwise specified in this report.

Thermal image scan for moisture leaks: Dry

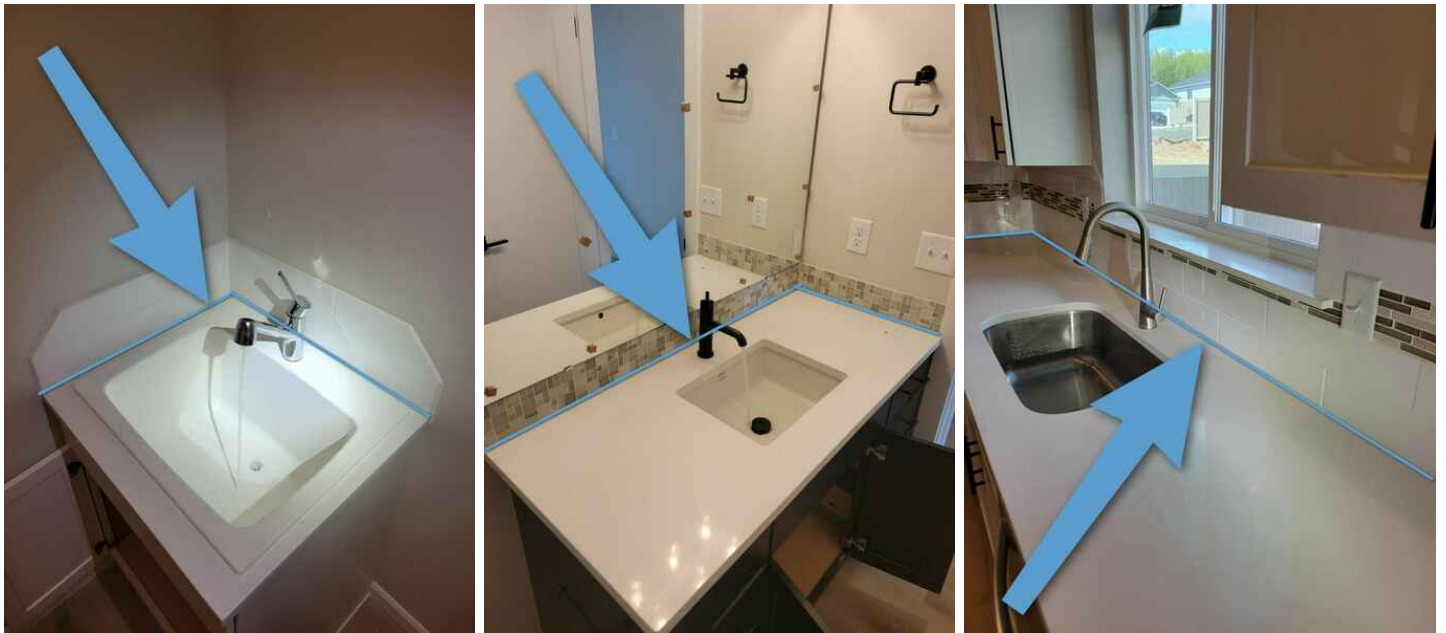
**POOR/MISSING SEAL**

One or more countertops were missing sufficient caulk/sealant at the countertop to wall/backsplash connection. This can lead to water damage behind the countertop. Recommend adding sealant at sides and corners where counters touch walls and backsplashes.

Contact a handyman or DIY project

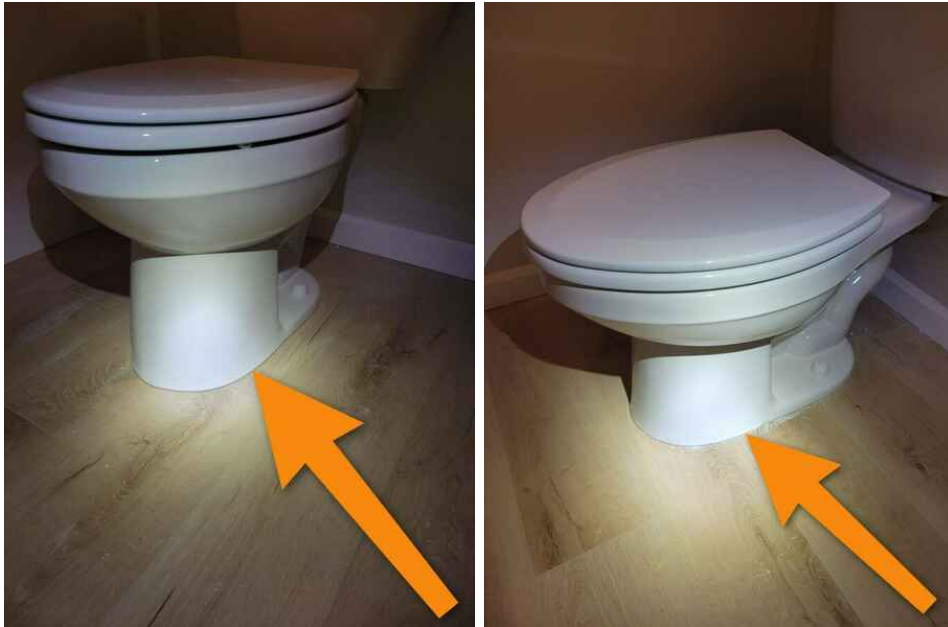
10.5.1 Bathroom Toilet(s)

**MISSING SEALANT**

One or more toilets had missing/deteriorated caulking/sealant at the base of the toilet to floor connection. Sealant helps secure the toilet to the floor and prevents movement. Recommend sealing/caulking as needed.

Contact a handyman or DIY project

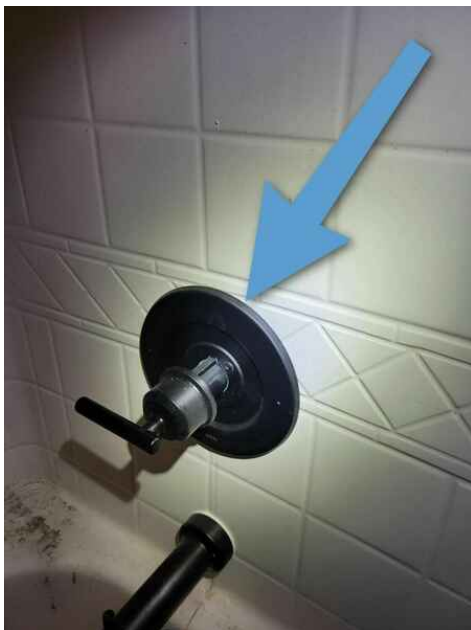
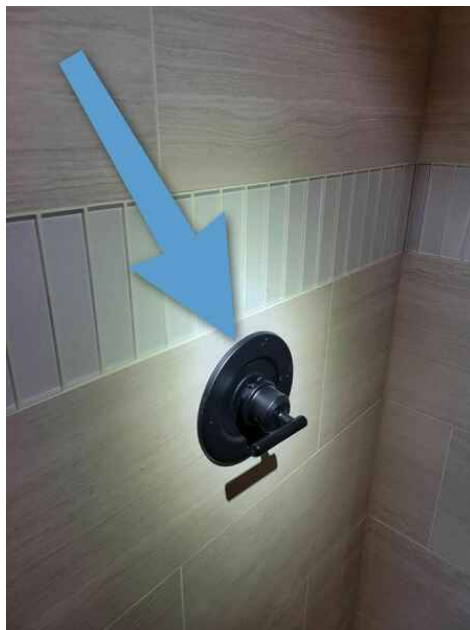
10.6.1 Bathtub & Shower Enclosure(s)

POOR/MISSING SEALANT

One or more areas of the shower enclosure(s) were missing sufficient caulk/sealant at recommend locations (e.g. enclosure transitions to wall/floor, water valves/faucets, penetrations, etc.) This condition creates a potential for moisture intrusion behind the shower enclosure. Recommend applying sealant to prevent moisture intrusion and damage.

Escutcheon plate(s) missing seal.

Contact a handyman or DIY project

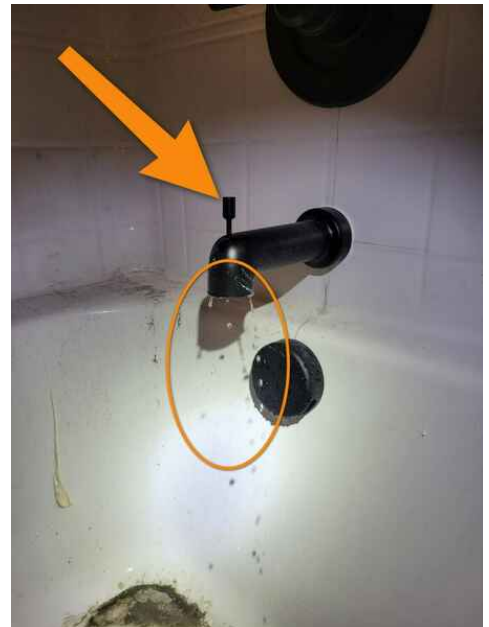
10.7.1 Bathtub & Shower Fixture(s)

DIVERTER VALVE LEAKED

The shower head diverter valve at the bathtub faucet did not fully divert water to the shower head as intended. This creates a condition for water loss and increased utility usage. Recommend a qualified contractor to make repairs.

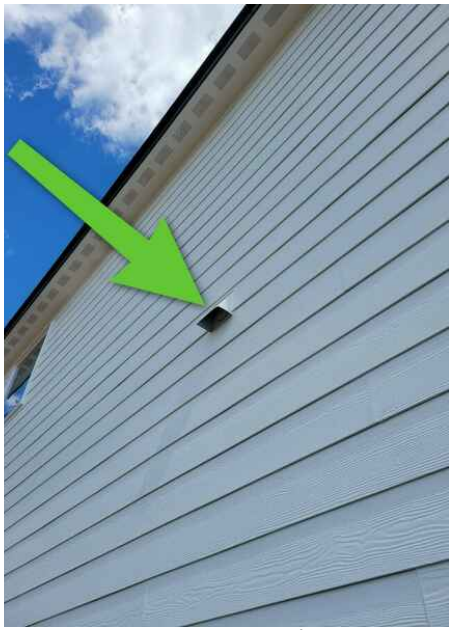
Exterior west side.

The clothes dryer exhaust system appeared in acceptable condition and appeared to function as intended, unless otherwise specified in this report.

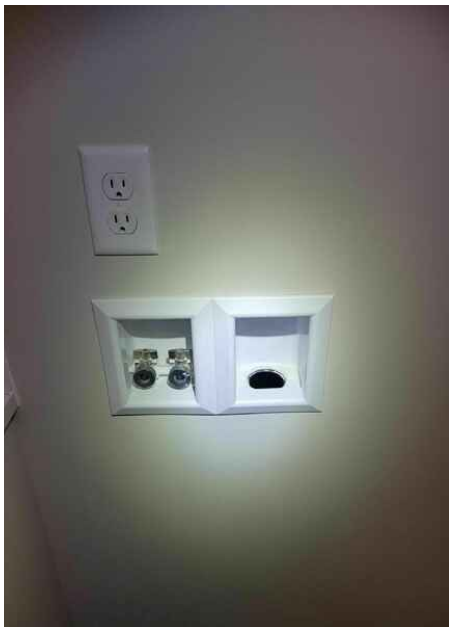
The clothes washer plumbing appeared in acceptable condition and appeared to function as intended, unless otherwise specified in this report.

Water supply pipes/valves and drain pipe.

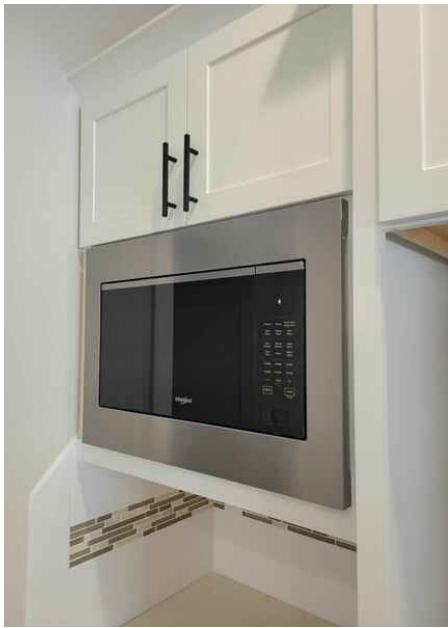
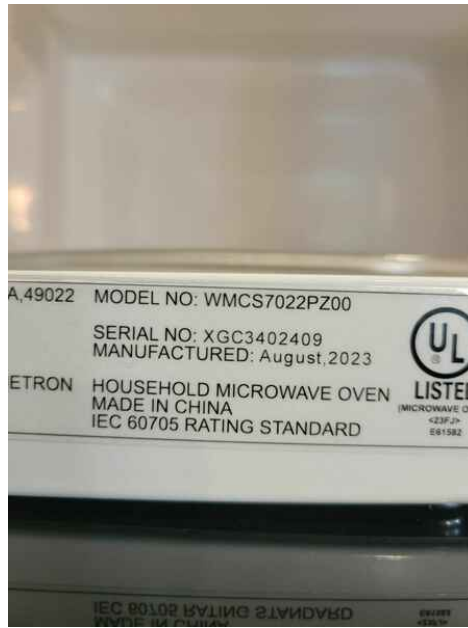
Built-In Microwave: Serviceable

The built-in microwave appeared in acceptable condition and appeared to function as intended, unless otherwise specified in this report.

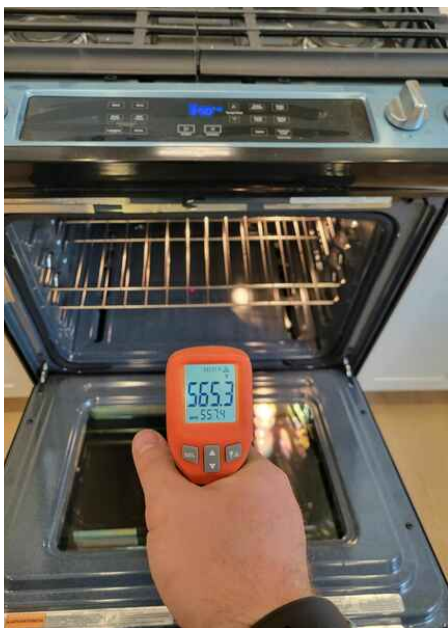
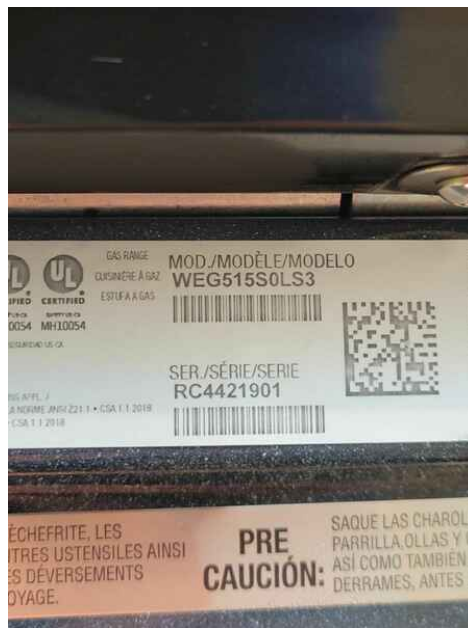
Range/Oven/Cooktop: Serviceable

The range, oven, and/or cooktop appeared in acceptable condition and appeared to function as intended, unless otherwise specified in this report.

Thermal image scan for operational heating: Normal

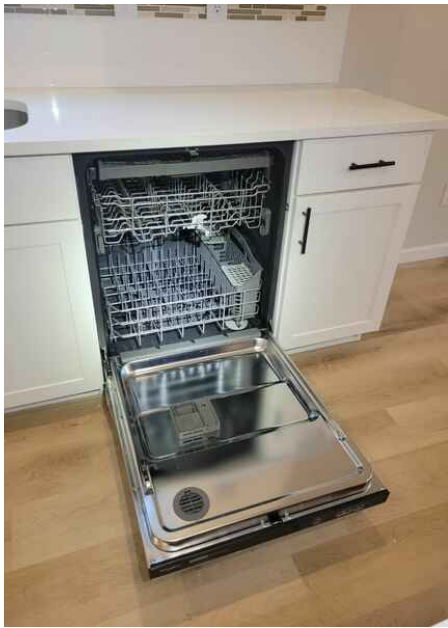
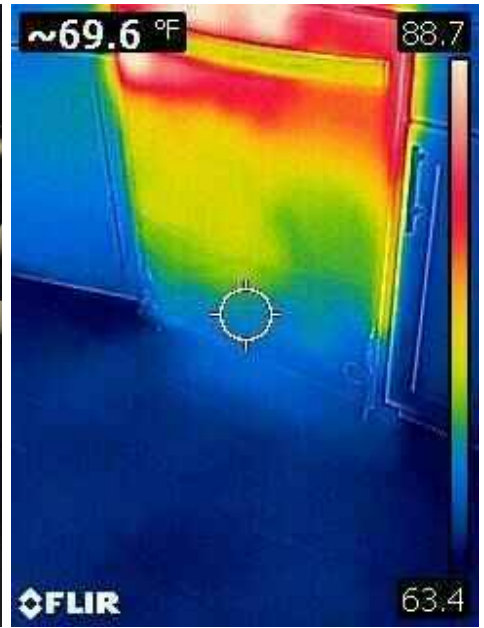
Dishwasher: Serviceable

The dishwasher appeared in acceptable condition and appeared to function as intended, unless otherwise specified in this report.

Thermal image scan for moisture leaks: Dry

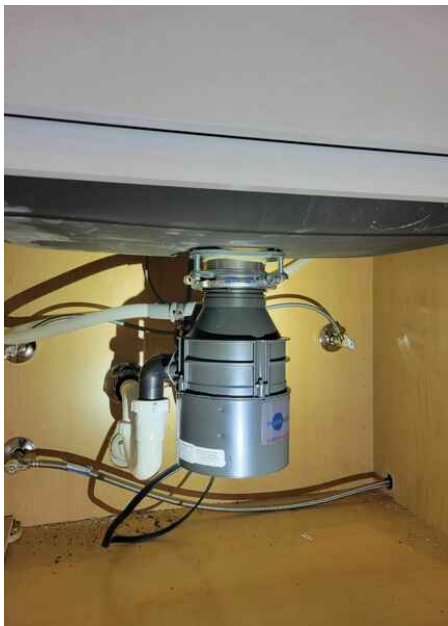
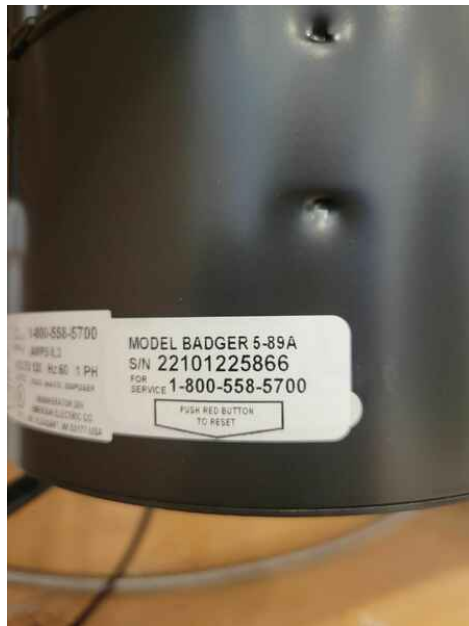
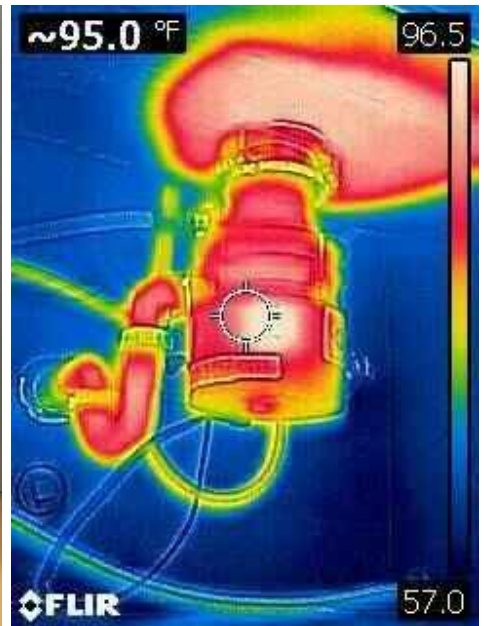
Sink Garbage Disposal: Serviceable

The garbage disposal appeared in acceptable condition and appeared to function as intended, unless otherwise specified in this report.

Thermal image scan for moisture leaks: Dry

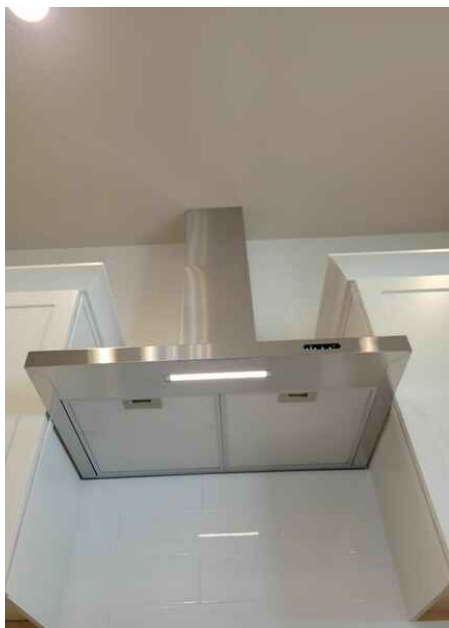
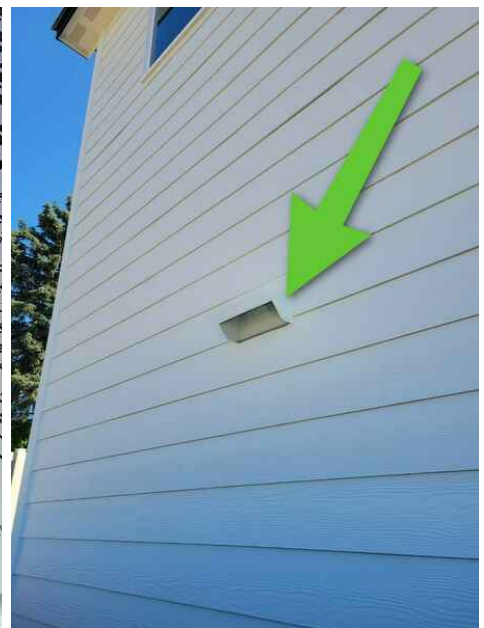
Kitchen Exhaust: Serviceable

The kitchen exhaust system appeared in acceptable condition and appeared to function as intended, unless otherwise specified in this report.

Exterior west side.

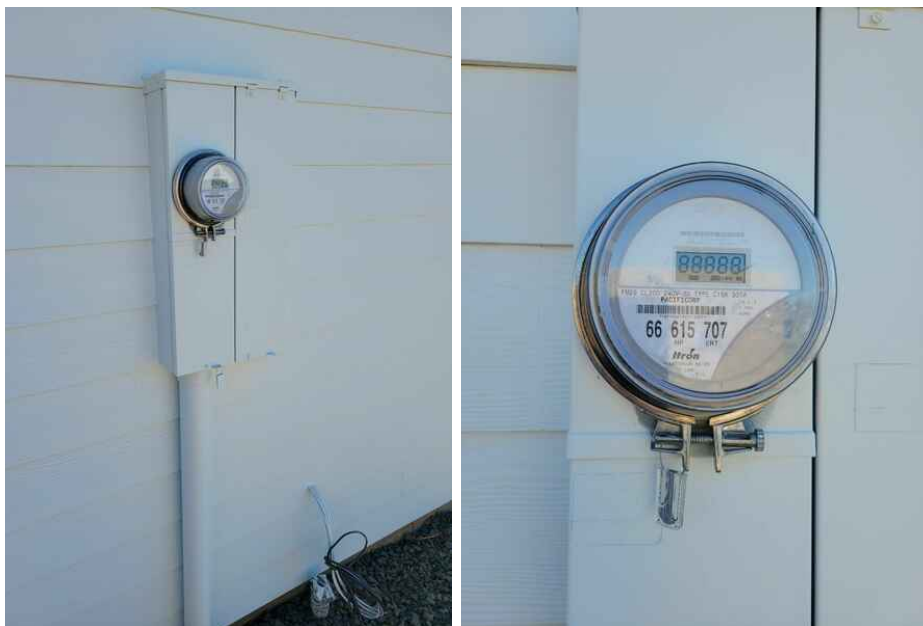
Service Meter(s): Serviceable

The electrical service meter appeared in acceptable condition and appeared to function as intended, unless otherwise specified in this report.

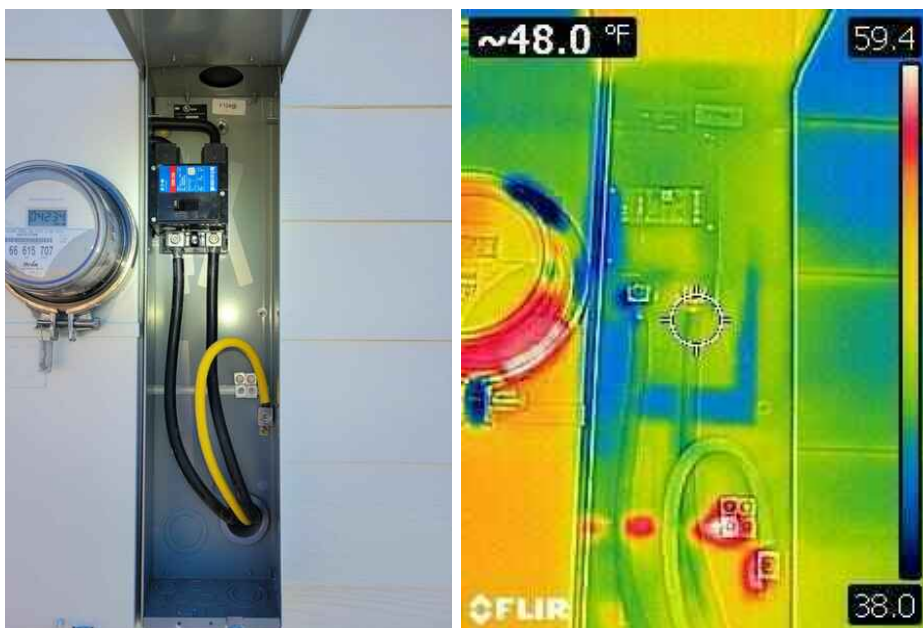
Main Panel, Main Disconnect, Breakers & Fuses: Serviceable

The main electrical panel appeared in acceptable condition and appeared to function as intended, unless otherwise specified in this report.

Thermal image scan for overheating breakers: Normal

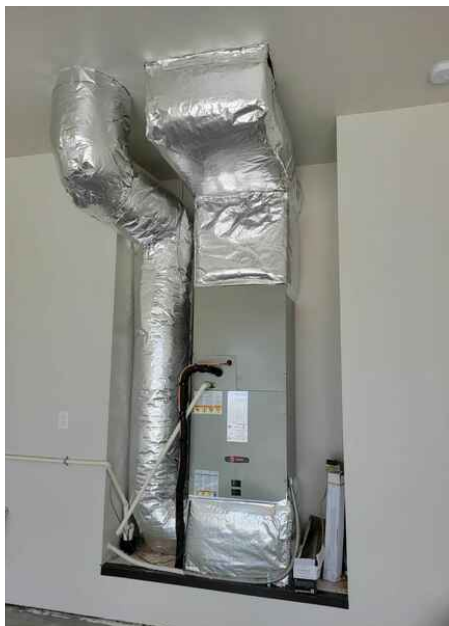
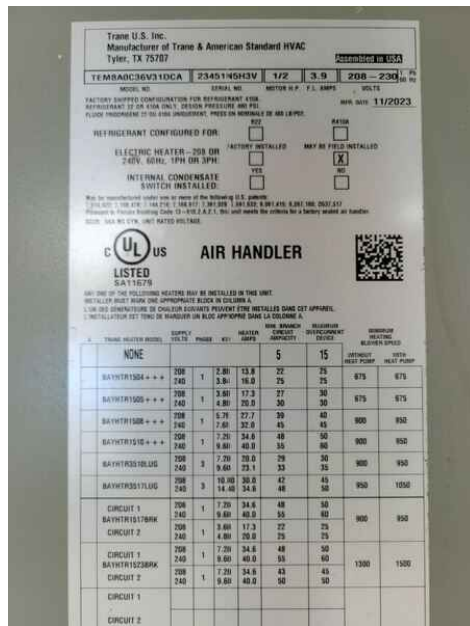
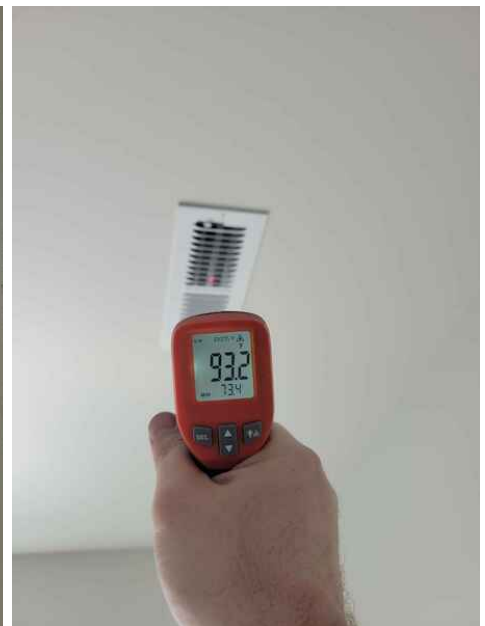
Heating System: Forced Air Furnace - Serviceable

The visible components of the forced air furnace appeared in acceptable condition and appeared to function as intended, unless otherwise specified in this report.

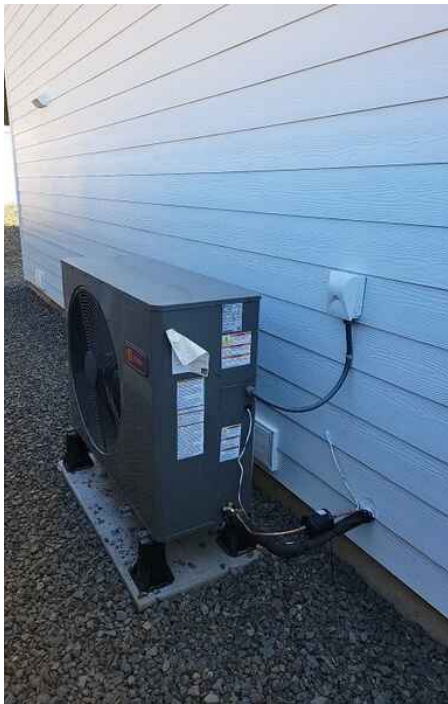
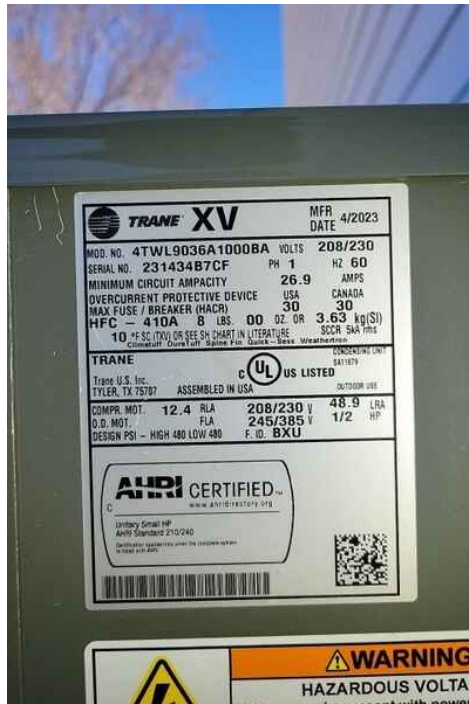
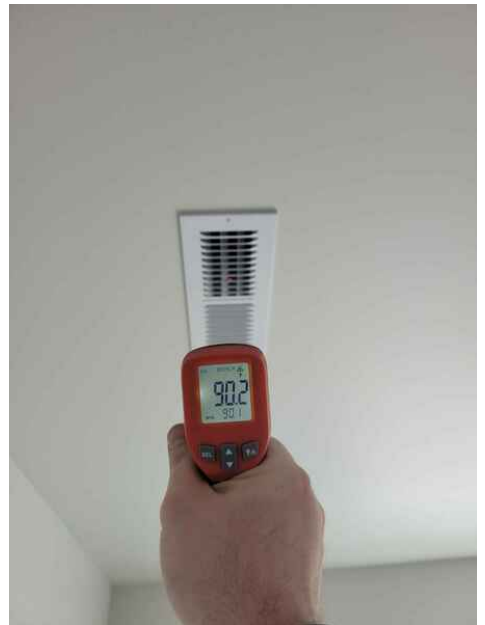
Cooling System: Heat Pump - Serviceable

The visible components of the heat pump system appeared in acceptable condition and appeared to function as intended, unless otherwise specified in this report.

The cooling system/function was not tested or operated due to low outdoor temperature. The outdoor ambient air temperature was below 65 degrees Fahrenheit. Running the A/C with temperatures this low can potentially cause damage to the unit. Inspection of the cooling system was limited. Recommend operating the cooling system on a warmer day to ensure functionality.

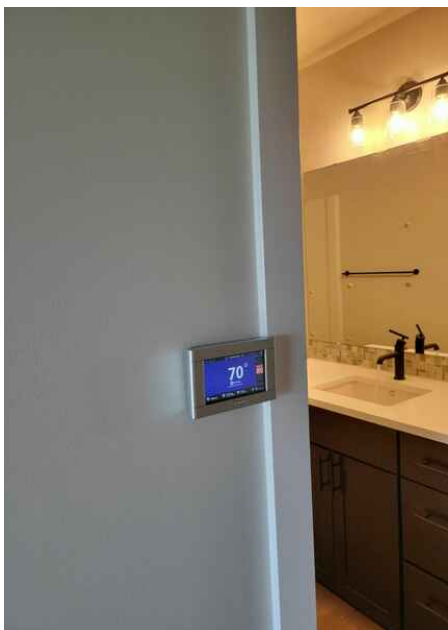
Operating Controls (Thermostat): Serviceable

The operating controls (thermostat) appeared in acceptable condition and appeared to function as intended, unless otherwise specified in this report.

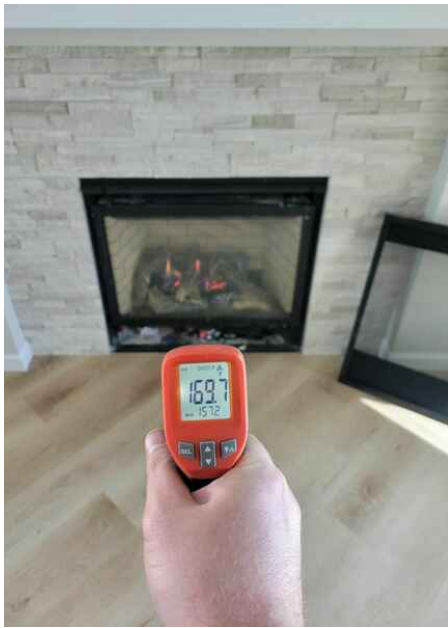
Fireplace(s): Serviceable

The fireplace(s) appeared in acceptable condition and appeared to function as intended, unless otherwise specified in this report.

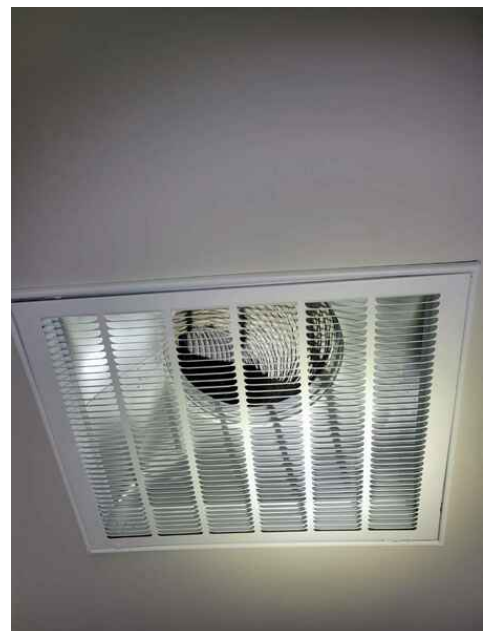
An filter was missing at the time of inspection. Recommend installing air filter as needed for improved indoor air quality and heating performance.

Return air register did not have a filter.

Contact a handyman or DIY project

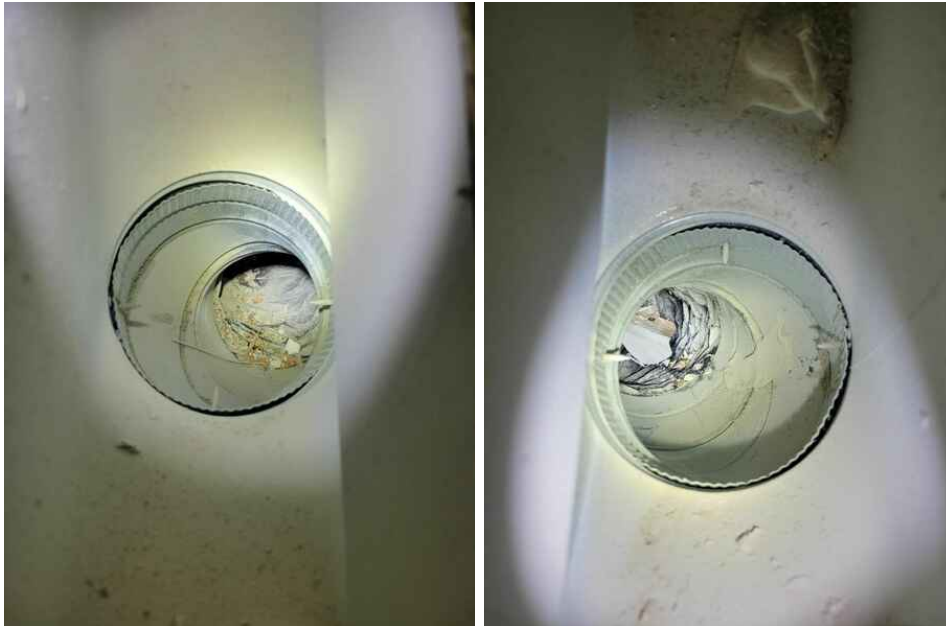
13.6.1 Distribution System

The ductwork was filled with debris. This condition can compromise the indoor air quality of the home. Recommend a qualified contractor to clean the ductwork.

Contact a qualified HVAC professional.

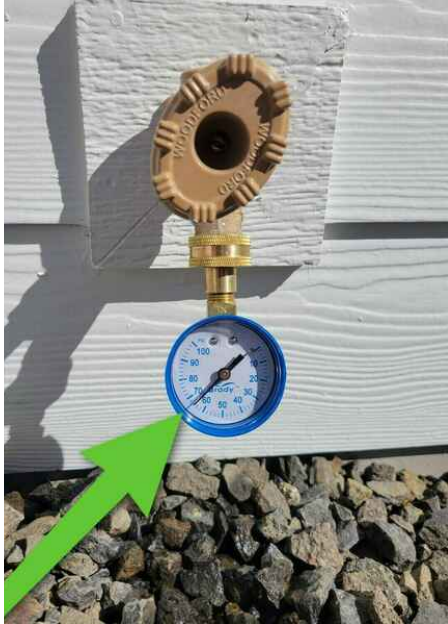
The water pressure was within an acceptable range at the time of the inspection. Average water pressure for residential homes is generally between 40 and 80 pounds per square inch (psi).

Water pressure tested ~68 psi.

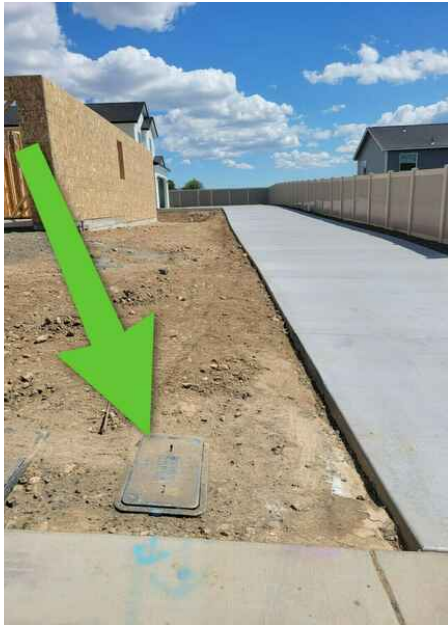
Water meter location.
