3D PROPERTY INSPECTIONS LLC

SAMPLE INSPECTION REPORT

1234 Main Street
Yakima, WA 98903

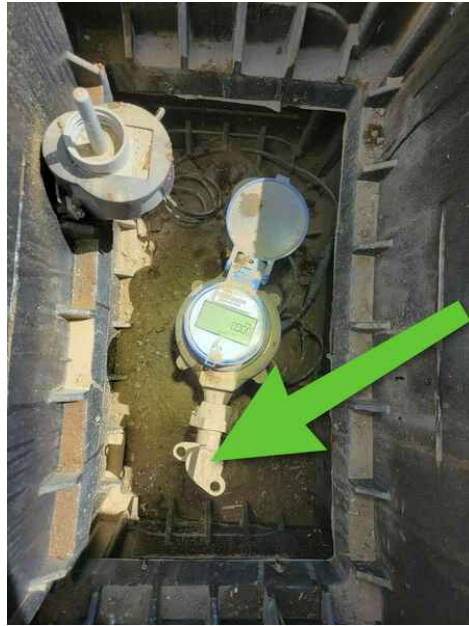
Water meter with main shut-off valve.

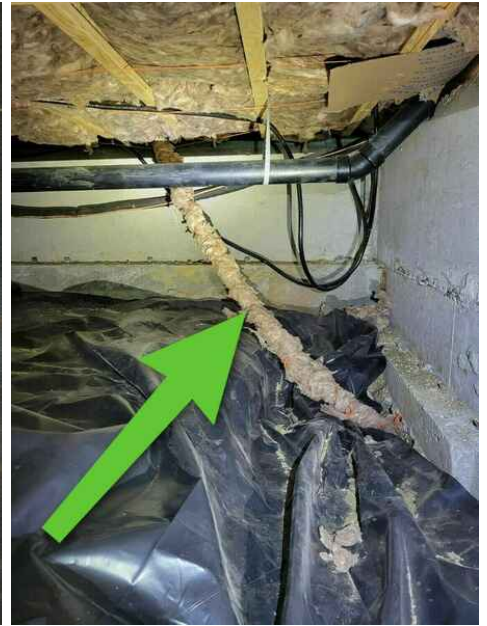
Main water supply pipe. Southwest crawlspace.

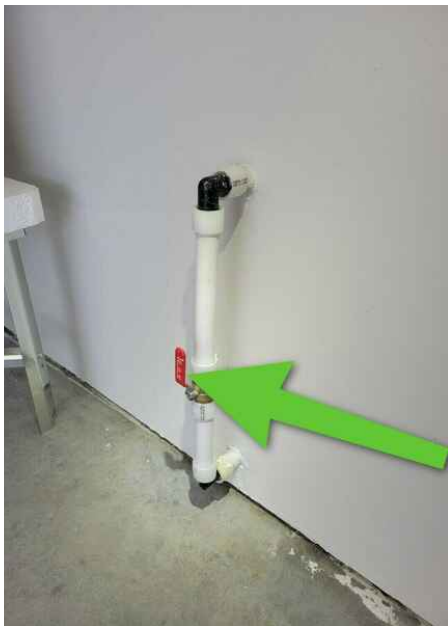
Main water supply pipe in garage with shut-off valve.

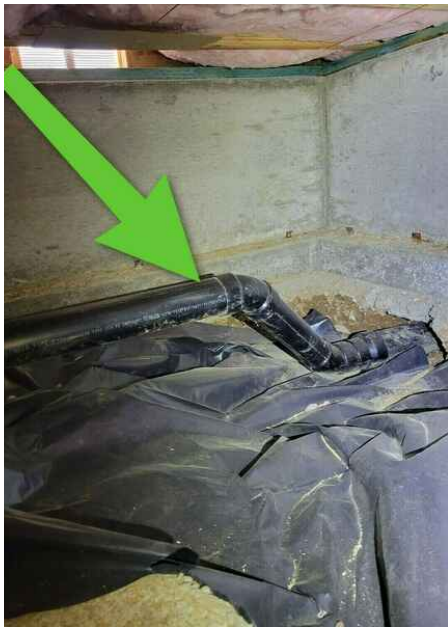
Main drain pipe. Southeast crawlspace.

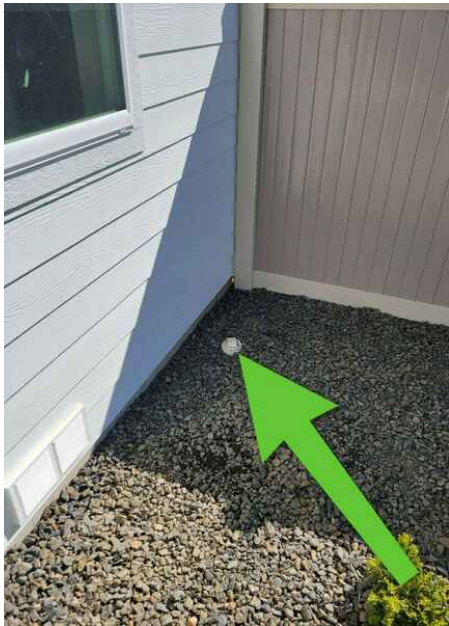
One or more clean outs on the main drain pipe were observed. A clean out is an addition to the home's plumbing system, and is intended to give plumbing professionals an easy access point through which they can reach clogs and backups. Recommend keeping these area(s) clear for easy access.

South side.

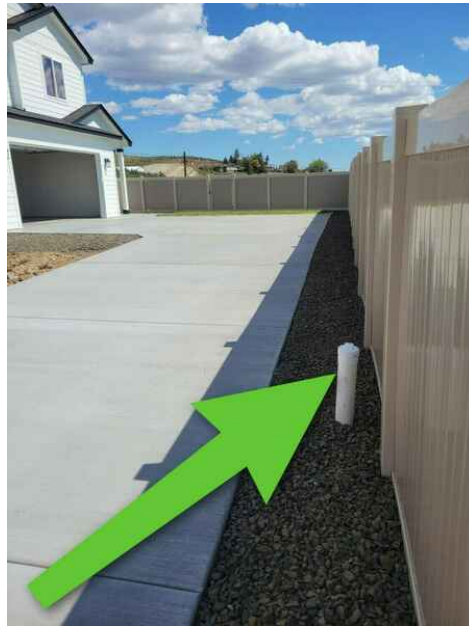
Driveway.

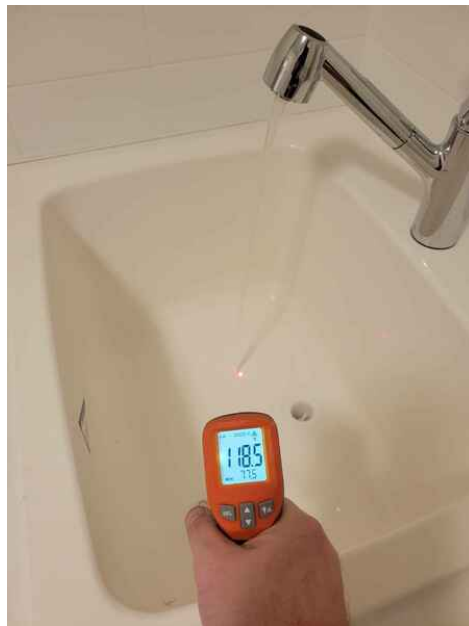
Water Heating System: Electric - Serviceable

The visible components of the electric water heater appeared in acceptable condition and appeared to function as intended, unless otherwise specified in this report.

Thermal image scan for moisture leaks: Dry

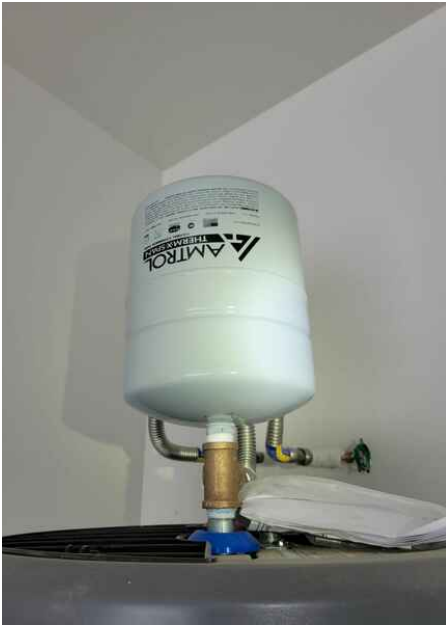
Expansion Tank: Serviceable

The thermal expansion device appeared in acceptable condition and appeared to function as intended, unless otherwise specified in this report.

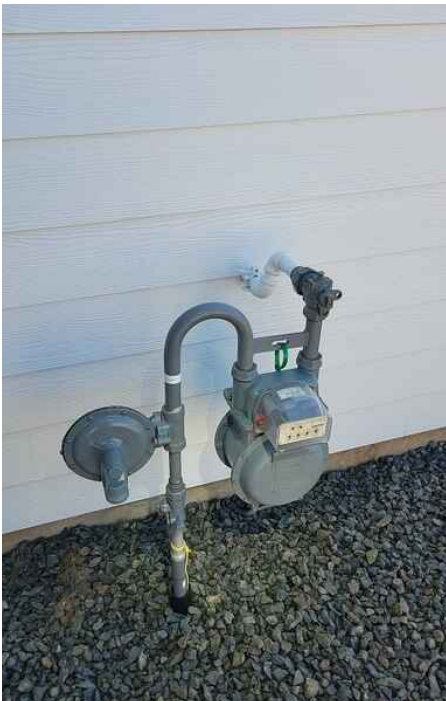
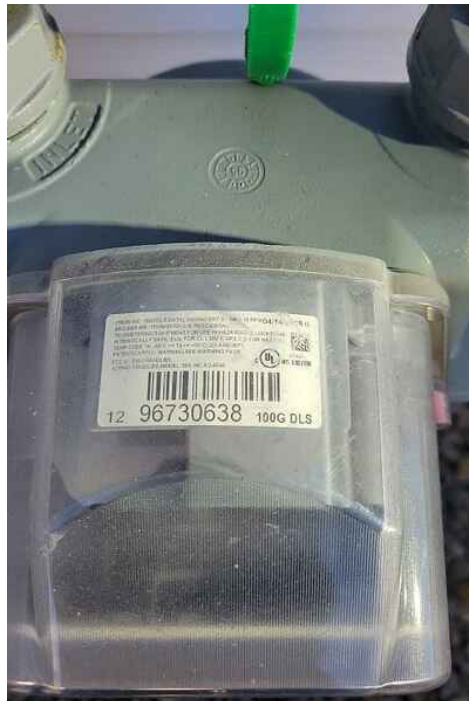
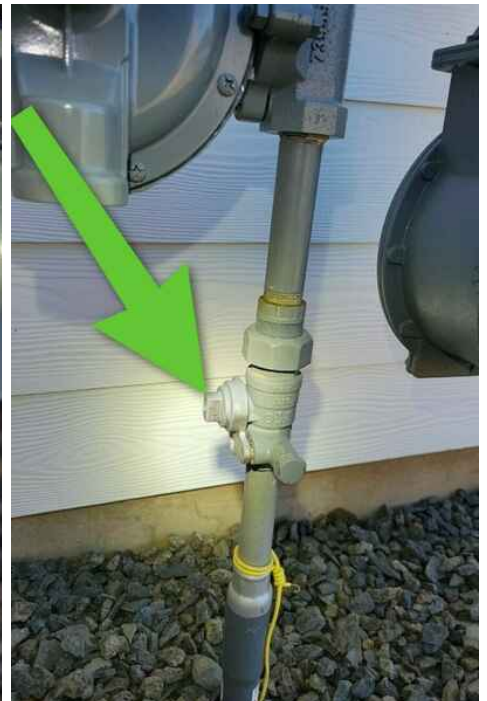
The visible components of the natural gas system appeared in acceptable condition and appeared to function as intended, unless otherwise specified in this report.

Main utility shutoff valve.

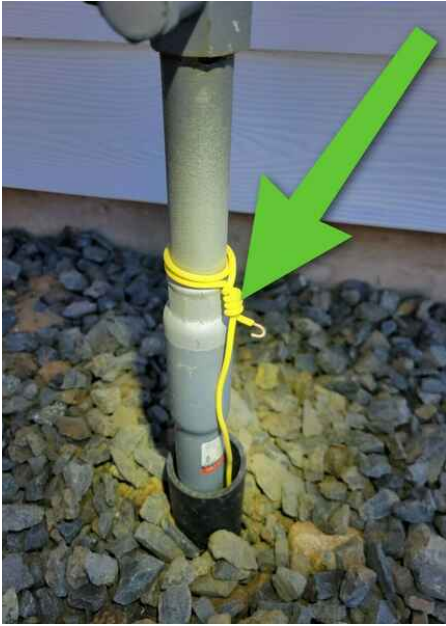
The gas meter had a tracing wire installed. Tracing wires are used for locating buried utilities going into, and from, the residence. Tracing wires are not live and do not pose an electrical/safety hazard, and are best left undisturbed for future locating. Comment for informational purposes only.

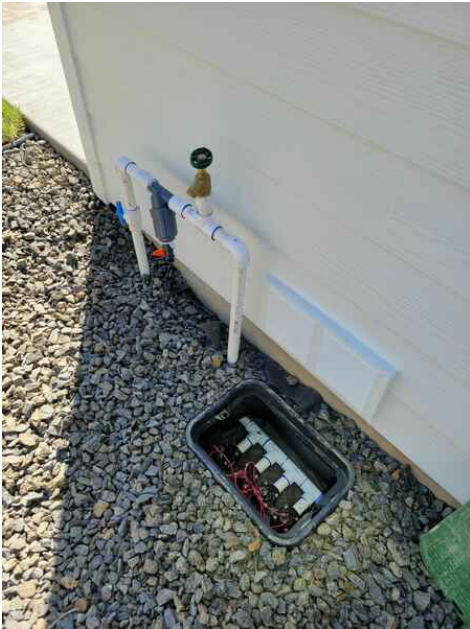
A landscape irrigation system was observed on the property. Landscape irrigation systems, and/or sprinkler systems, are outside the scope of a standard home inspection. Much of the system is either inaccessible, buried, or difficult to view. The system was excluded from the inspection and inspection report. It is recommended that a qualified professional evaluate and demonstrate the irrigation system operation prior to use.

Exterior northeast corner.

Tip: ensure the sprinkler system is not spraying too close to the house, and its foundation, as this can lead to moisture damage to the exterior siding system and water intrusion into the crawlspace/basement.

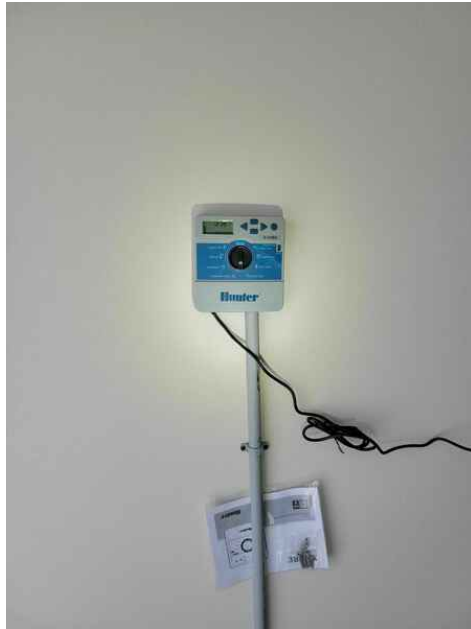
Control hub. Garage.
